2016 FACILITIES IMPROVEMENT PLAN

Bear River
High School

INTRODUCTION

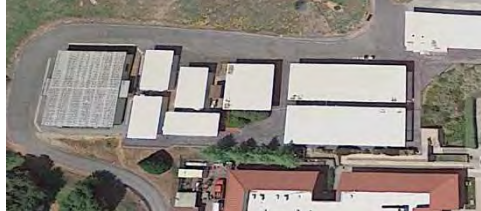
Building G Portables	\$ 362,069

\$ 242,916
BR 5	Building G Relocatable Improvements	HP	<ol style="list-style-type: none"> 1. Replace HVAC Wall Mounted Heat Pump Units. 2. Remove and replace damaged exterior siding 3. Interior Modernization. <p>Allow: Replacement of (5) Heat Pumps Replacement of +/-1200 s.f. of siding</p>

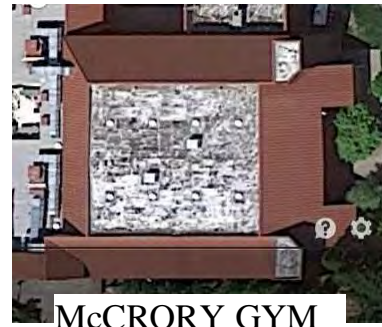
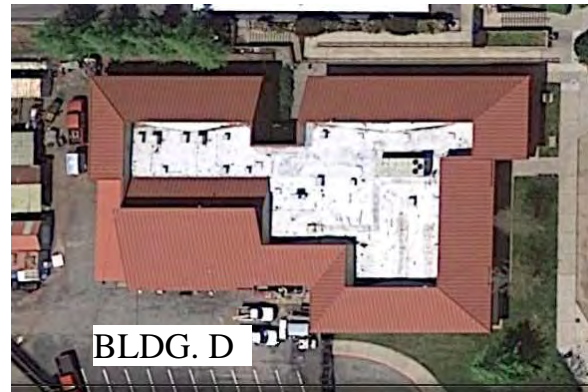
BR 6	New Roofing - Units B, D & McCrory Gymnasium	HP	Existing built-up system at flat roof mechanical wells need replacing - Study alternatives. District has used single - ply overlay on several replacements over the past 10 years.

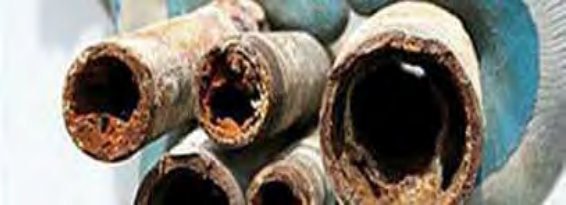
ITEM	SCOPE	Urgency Score	NARRATIVE DESCRIPTION / COMMENTS	DESCRIPTIVE SCOPE IMAGES	ROUGH ORDER OF COST MAGNITUDE
BR 7	Replacement of underground HVAC Hydronic Piping	HP	Liquefied gas fired central boilers provide heat to campus. Boilers are new (Bryant boilers are LPG and should last 30 years) and will not need replacing. Pumps will need to be replaced. Concept will be to go overhead in attic and plenum spaces.

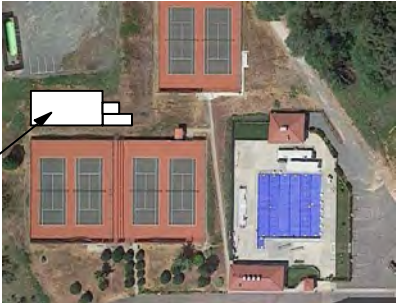
BR 13	Solar Panel System at Aquatic Center.	LP	District had preliminary discussions with a designer a few years ago. Pool was built approx 2007. The pool heater, as with most all of the campus is powered with liquefied propane. Solar panels would augment this heat source. At grade secure solar array on adjacent south facing slope is probable location The Bear River High School Pool is 25 yards by 25 meters, which is 6,150 square feet. The solar panels need to be at least 80% of the pool's surface area, which would be 5,000 square feet of solar collector. Using 48-square-foot panels, this is 105 panels.	Approximate Solar Panel Array Locations

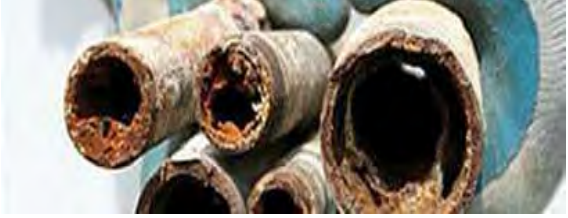
ITEM	SCOPE	Urgency Score	NARRATIVE DESCRIPTION / COMMENTS	DESCRIPTIVE SCOPE IMAGES	ROUGH ORDER OF COST MAGNITUDE
NU 1	Replacement of all Underground Gas Lines	HP	Abandon existing lines in place. Change over coordination will be an issue needing coordination. Abandon in place and replace +/- 2,000lf of 1 1/2" gas line and associated valves.

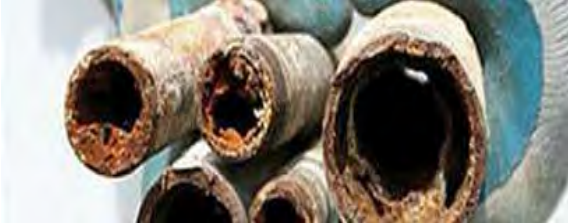
\$ 188,782
NU 2	Replacement of All Underground Transite Utility Lines.	HP	<p>This will include domestic water and sanitary sewer lines. Some storm lines may be transite as well.</p> <ol style="list-style-type: none"> 1. Remove and replace +/- 700lf (e) 8" sanitary sewer line. (e) manholes are OK. 2. Remove and replace +/- 720lf (e) 6" sanitary sewer line. 3. Remove and replace +/- 1600lf (e) 6" PVC C900 domestic water line. 4. Add +/- 1600lf 8" PVC C900 fire line 5. Remove and replace +/- 1600lf of 8" storm sewer line

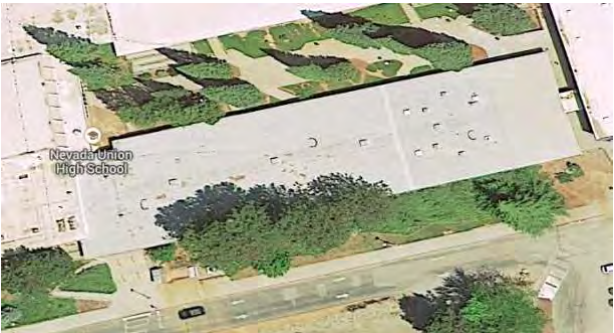
\$ 288,658
NU 7	Replacement of Roofing at Bldgs. C, E, J, K, L	HP	Remove existing built-up roofing. Replace with single-ply roofing – Sarnafil.

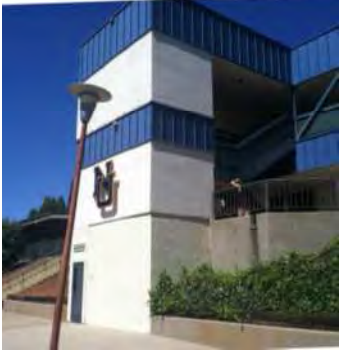
ITEM	SCOPE	Urgency Score	NARRATIVE DESCRIPTION / COMMENTS	DESCRIPTIVE SCOPE IMAGES	ROUGH ORDER OF COST MAGNITUDE
NU 8	Correct Waterproofing Issue at Elevator - Bldg. J.	HP	Water leak at second floor cannot be found – Elevator consultant to be involved - Siskiyou Elevator

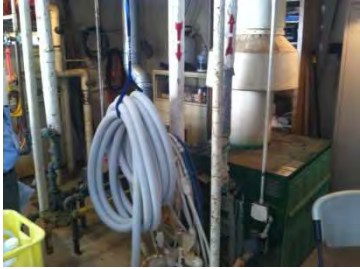
\$ 256,585
NU 9	New Main Boiler at Swimming Pool Building P	HP	Remove existing Laars AF-2730 boiler and associated piping and flue. Install (2) new swimming pool condensing boilers (89% AFUE), Lochinvar Copper-Fin2 pool heater Model CPN1262.Requires secondary pump and all new piping. Extensive rework of existing layout and possible floor modifications. Alternatively install (1) new swimming pool boiler (89% AFUE), Lochinvar Copper-Fin2 Model CPN2072 with associated new pump. Install new flue(s) and reconnect gas piping and swimming pool

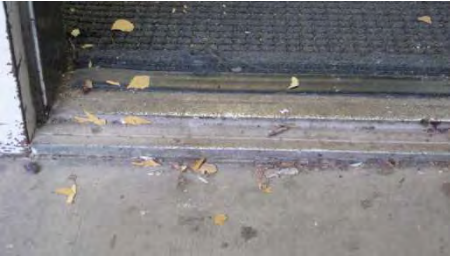
ITEM	SCOPE	Urgency Score	NARRATIVE DESCRIPTION / COMMENTS	DESCRIPTIVE SCOPE IMAGES	ROUGH ORDER OF COST MAGNITUDE
NU 28	Upgrade Exterior Door Thresholds	MP CR	<p>Several exterior door thresholds do not meet the CBC (1" tall threshold maximum). Remove and replace existing exterior concrete landing to meet CBC.</p> <p>Allow (12) doors.</p>
