2016 FACILITIES IMPROVEMENT PLAN

Bear River
High School

INTRODUCTION

Proposed Bear River High School Improvements

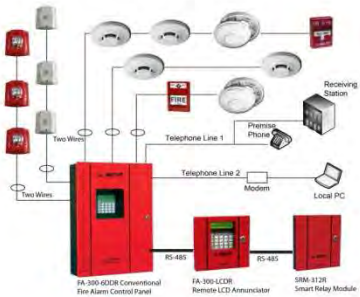
ITEM	SCOPE	Urgency Score	NARRATIVE DESCRIPTION / COMMENTS	DESCRIPTIVE SCOPE IMAGES	ROUGH ORDER OF COST MAGNITUDE
BR 1	Replace Fully Automated Fire Alarm System	HP	Existing non-addressable Simplex System in all buildings with the possible exception of Building L (Library built in 2000 and the Performing Arts Bldg. 2005). There are moisture issues (ground faults) with the underground signal wiring between buildings - This is a common issue for most systems between buildings on this site. Consider all conductors in conduit.

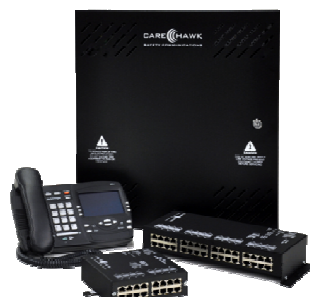
955,823
BR 2	Replace Public Address System – Head End	HP	Existing Dukane System needs to be replaced with Dukane Carehawk or similar system. Head end only.

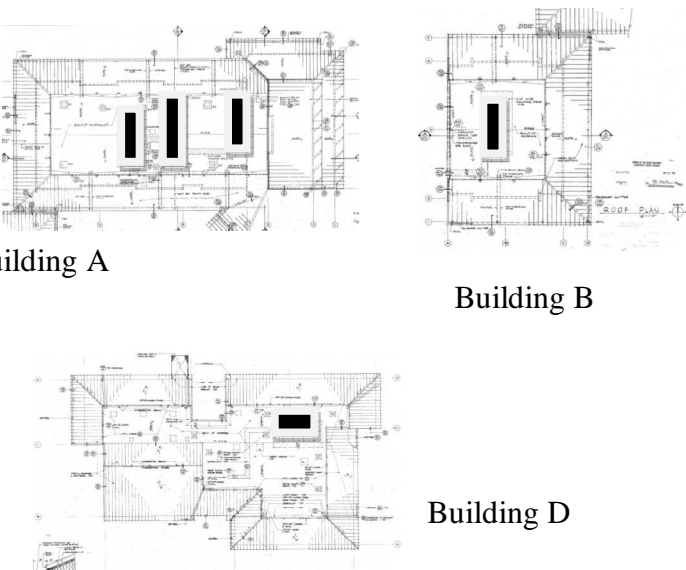
\$ 230,926
BR 3	Replace HVAC ‘Boxcar Units’ Building. A,B,& D Replace/Upgrade Ventilation System in Shop Room, Art Room, Clay Room & Dark Room – Building D	HP	Main air handles at roof – DX cooling. Building D will ‘stand alone’ and shall be served by the liquid propene tank in the adjacent yard. Existing Delta energy management system is ‘backnet’ and can handle new units via data connections. Remove and replace in like kind existing AC units; four (4) 25 ton units, one (1) 50 ton unit. Furnished with adapter curb, air economizer, fault detection diagnostics, VFD drives on supply and return fans, filter bank, building pressure controls, fully integrated controls to EMS system for optimization and new Title 24 requirements for VAV systems. Four (4) indoor air-handlers with hot water heating coils: Capacity range: 1100 cfm, 1650 cfm, 1060 cfm, & 2800 cfm all rated at 1.25" TSP. Remove and install new of like kind reconnecting ductwork, power, controls, and piping. All four (4) air-handlers have associated in-line exhaust fans of same capacity. Remove and replace in like kind. Reconnect power, controls and ductwork.

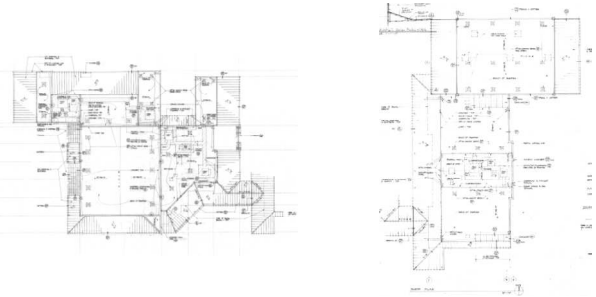
ITEM	SCOPE	Urgency Score	NARRATIVE DESCRIPTION / COMMENTS	DESCRIPTIVE SCOPE IMAGES	ROUGH ORDER OF COST MAGNITUDE
BR 4	Replace HVAC Rooftop Units - Building E & Building F	HP	Remove and replace in like kind existing AC unit (cooling only with HW reheat coils downstream): one (1) 3 ton unit, one (1) 4 ton unit, two (2) 7.5 ton units, one (1) 10 ton unit. Units over 4 ton furnished with adapter curb, air economizer, fault detection diagnostics, and new Honeywell TB7600 or equal occupancy controlled smart thermostat. Units 4 ton and less furnished with adapter curb, new controls and outside air hood.

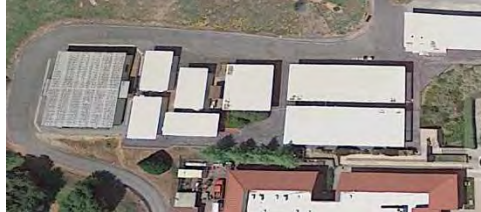
<p style="text-align: right;">Building G Portables</p>	\$ 588,719

\$ 242,916
BR 5	Building G Relocatable Improvements	HP	<ol style="list-style-type: none"> 1. Replace HVAC Wall Mounted Heat Pump Units. 2. Remove and replace damaged exterior siding 3. Interior Modernization. <p>Allow: Replacement of (5) Heat Pumps Replacement of +/-1200 s.f. of siding</p>

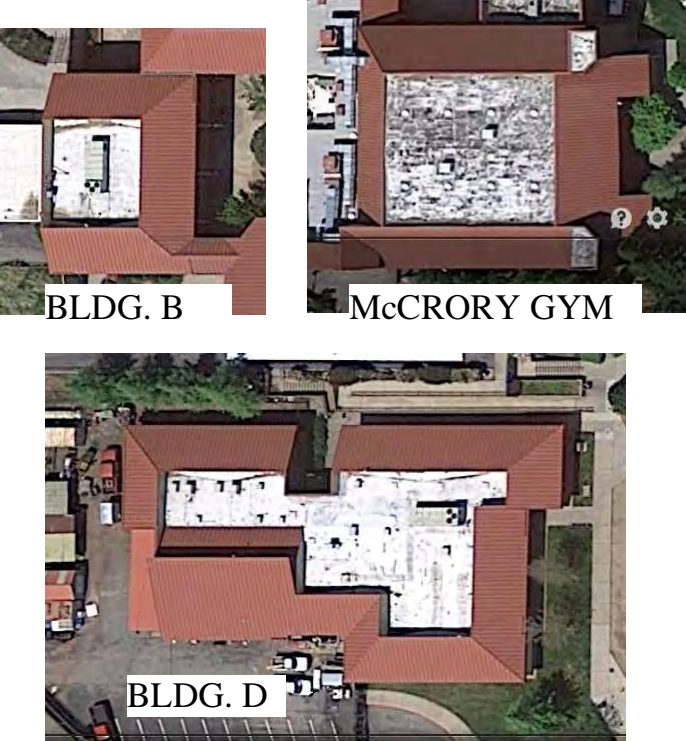
<p style="display: flex; justify-content: space-around;"> BLDG. B McCRORY GYM </p> <p style="text-align: center;">BLDG. D</p>	\$ 678,431

BR 6	New Roofing - Units B, D & McCrory Gymnasium	HP	Existing built-up system at flat roof mechanical wells need replacing - Study alternatives. District has used single - ply overlay on several replacements over the past 10 years.

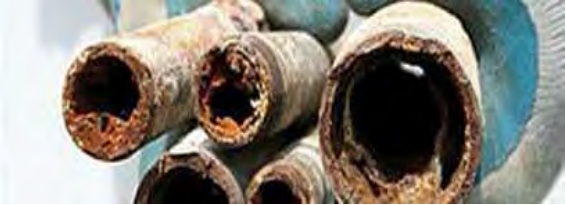
ITEM	SCOPE	Urgency Score	NARRATIVE DESCRIPTION / COMMENTS	DESCRIPTIVE SCOPE IMAGES	ROUGH ORDER OF COST MAGNITUDE
BR 7	Replacement of underground HVAC Hydronic Piping	HP	Liquefied gas fired central boilers provide heat to campus. Boilers are new (Bryant boilers are LPG and should last 30 years) and will not need replacing. Pumps will need to be replaced. Concept will be to go overhead in attic and plenum spaces.

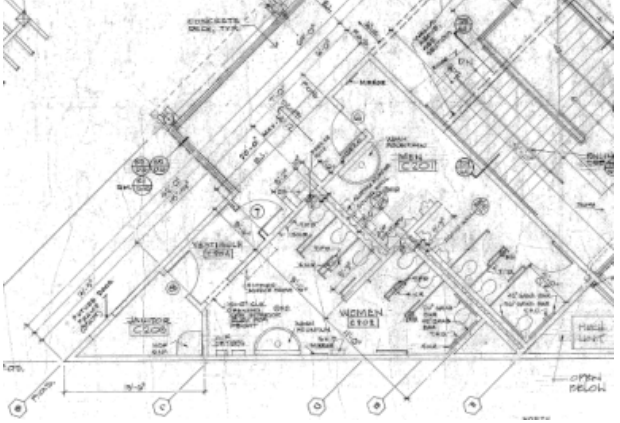
\$ 1,000,199
BR 8	Renovation Of All Restrooms. Make ADA Accessible	HP CR	Performing Arts building and Aquatic Center are the exceptions here. Gut and replace all fixtures and finishes

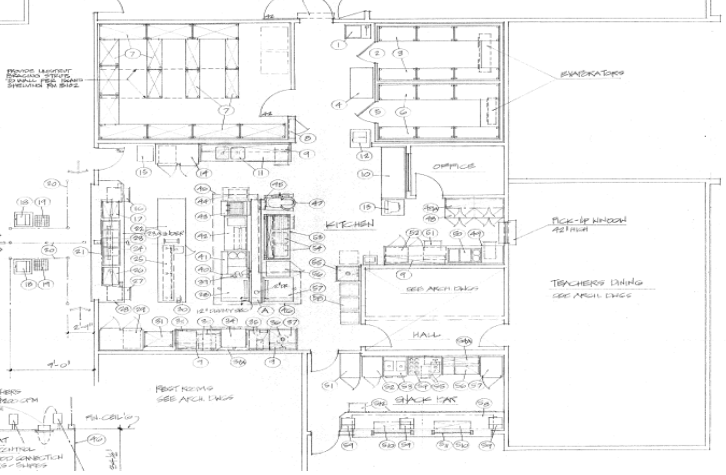
\$ 947,938
BR 9	Renovation of Building E Kitchen Facility	HP	Shall include replacement of walk-in freezer and refrigerator. This will be a complete gutting and renovation of this food service facility

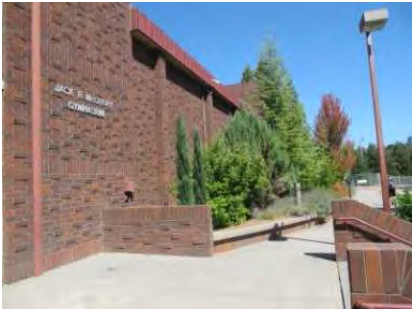
\$ 5,409,830
BR 16	Water Seal Exterior Tile at Buildings A-E	MP	\$400,000.00 in repair done in 2004 has stabilized this issue. Product: Professional Water Coating. Include value for re-application of the water sealing product.

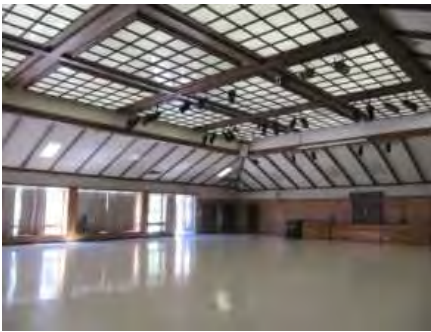
\$574,179
BR 19	Provide Cooling of Building E Cafeteria	MP	Remove existing 9000 cfm outdoor air-handler with hot heating water only. Install new 9000 cfm outdoor air-handler with hot water coils and integral DX cooling. Install new controls for heat and cooling along with new motorized dampers for air economizer cycle. Add new duct smoke detector, carbon dioxide controls, and new temperature controls for heating, cooling, air economizer cycle and fault detection diagnostics. Install new condensate drains. New power to unit for increased power requirements. New rooftop unit to be furnished with power exhaust.

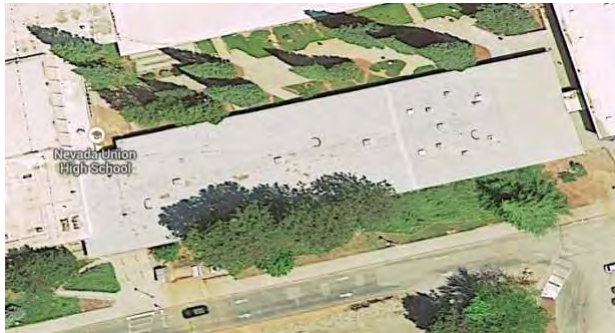
\$ 288,658
NU 7	Replacement of Roofing at Bldgs. C, E, J, K, L	HP	Remove existing built-up roofing. Replace with single-ply roofing – Sarnafil.

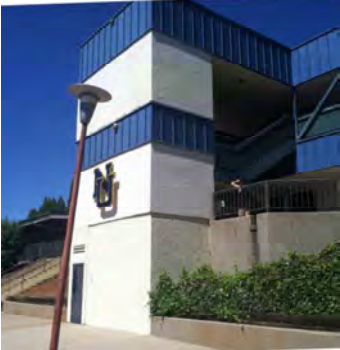
ITEM	SCOPE	Urgency Score	NARRATIVE DESCRIPTION / COMMENTS	DESCRIPTIVE SCOPE IMAGES	ROUGH ORDER OF COST MAGNITUDE
NU 8	Correct Waterproofing Issue at Elevator - Bldg. J.	HP	Water leak at second floor cannot be found – Elevator consultant to be involved - Siskiyou Elevator

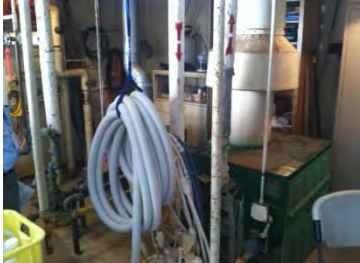
\$ 256,585
NU 9	New Main Boiler at Swimming Pool Building P	HP	Remove existing Laars AF-2730 boiler and associated piping and flue. Install (2) new swimming pool condensing boilers (89% AFUE), Lochinvar Copper-Fin2 pool heater Model CPN1262.Requires secondary pump and all new piping. Extensive rework of existing layout and possible floor modifications. Alternatively install (1) new swimming pool boiler (89% AFUE), Lochinvar Copper-Fin2 Model CPN2072 with associated new pump. Install new flue(s) and reconnect gas piping and swimming pool

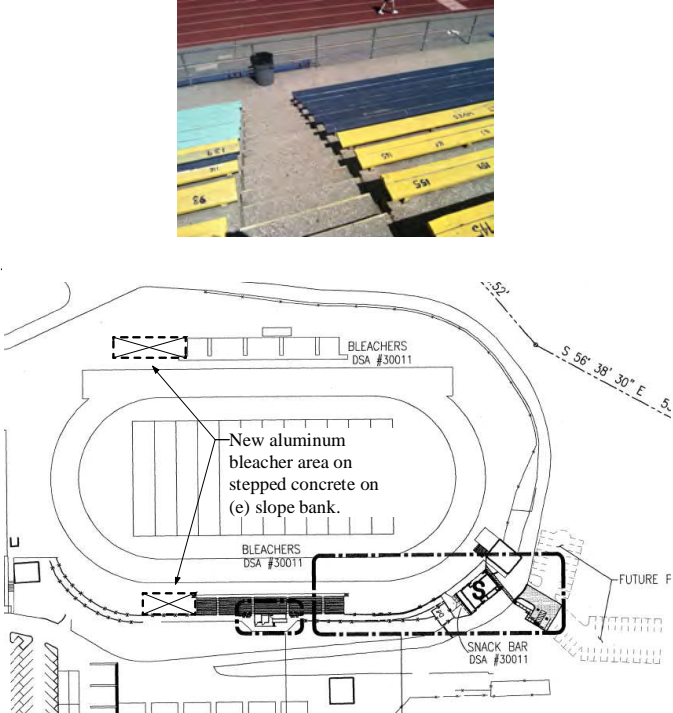
ITEM	SCOPE	Urgency Score	NARRATIVE DESCRIPTION / COMMENTS	DESCRIPTIVE SCOPE IMAGES	ROUGH ORDER OF COST MAGNITUDE
<p>NU 23</p>	<p>Football Stadium – Bleachers</p>	<p>LP</p>	<p>1. Existing wood bleachers on steel brackets are deteriorating. Replace with aluminum. 2. Add Bleachers at the South End of the Football Field. Brackets are mainly good – aluminum retrofit Area of new bleachers is +/- 5,000sf</p>

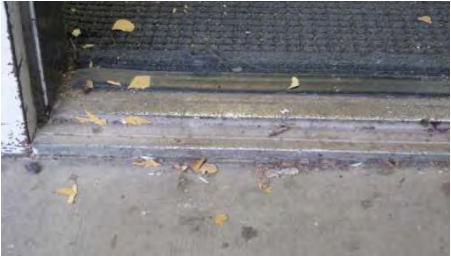
ITEM	SCOPE	Urgency Score	NARRATIVE DESCRIPTION / COMMENTS	DESCRIPTIVE SCOPE IMAGES	ROUGH ORDER OF COST MAGNITUDE
NU 28	Upgrade Exterior Door Thresholds	MP CR	<p>Several exterior door thresholds do not meet the CBC (1" tall threshold maximum). Remove and replace existing exterior concrete landing to meet CBC.</p> <p>Allow (12) doors.</p>

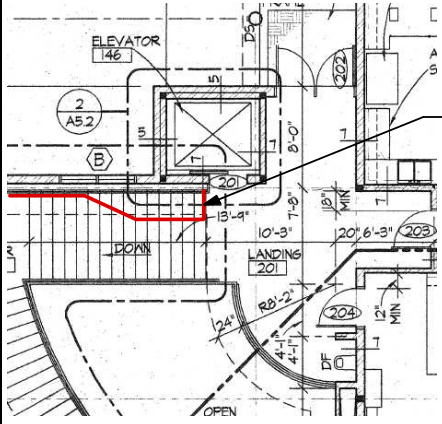
<p>Remove Carpet & Re-Finish (E) Conc. Surface</p>	<p>\$ 51,862</p>
<p>NU 36</p>	<p>Add Guardrail between Elevator and Stairs – Building S Library 2nd Floor</p>	<p>HP</p>	<p>On the 2nd Floor, the elevator opening is adjacent the top of the stairway. This is a safety issue. Add guardrail to create a barrier between the elevator opening and the top landing of the stairway.</p>

<p>Design new guardrail for safety at elevator opening.</p>	<p>\$9,622</p>
